Rebuilding the keel

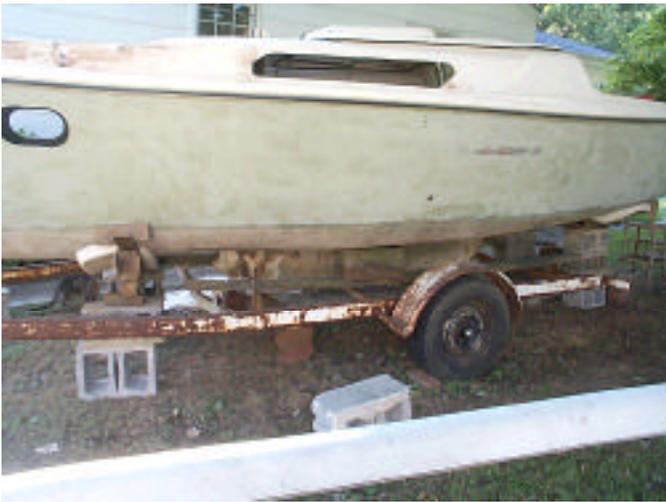
33. The boat going up. You can just start to see the keel underneath.

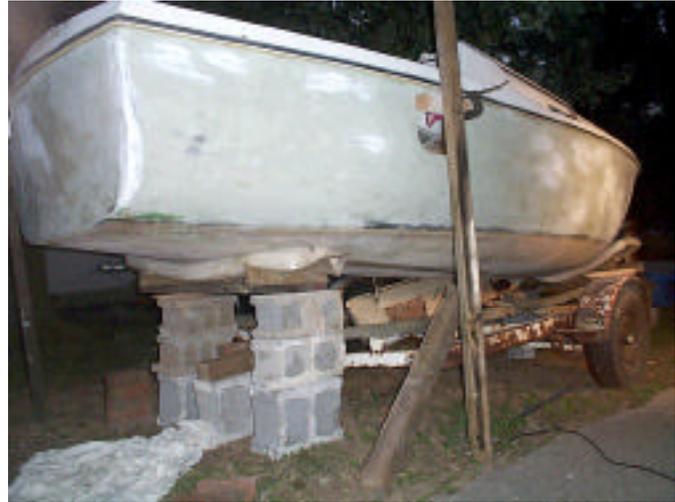
34. Aft view of the boat at it's highest point.

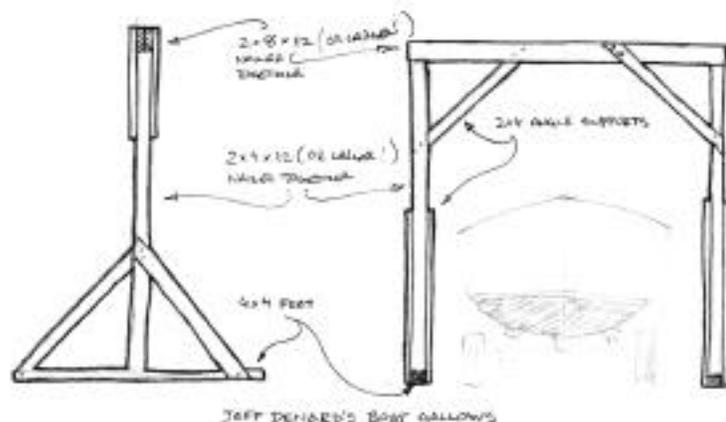
35. Jeff Denard's alternative method for lifting his boat

LIFTING OPTIONS-CONTINUED
 for the vertical piece that connects the two uprights.
 If the uprights are well braced and strong, this would be an easier and safer way to lift the boat, and one I'll employ next time. Assembled with bolts, a gallows can be disassembled and stored for later use. A heavy-duty crane strap and a pair of 'come-alongs' lift the boat.

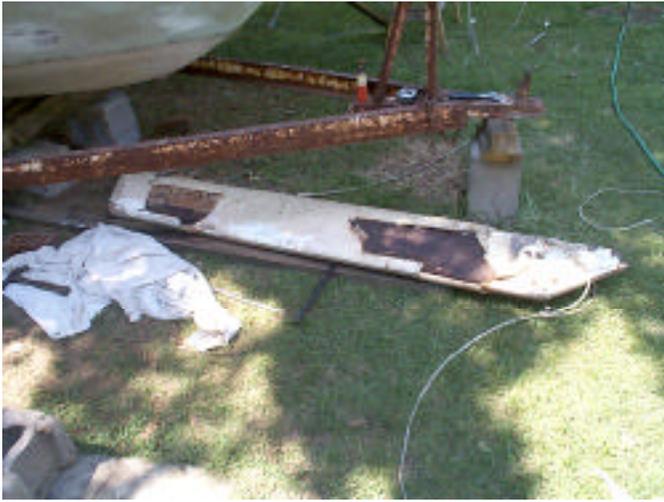
36. The keel removed, the boat back down on the trailer.

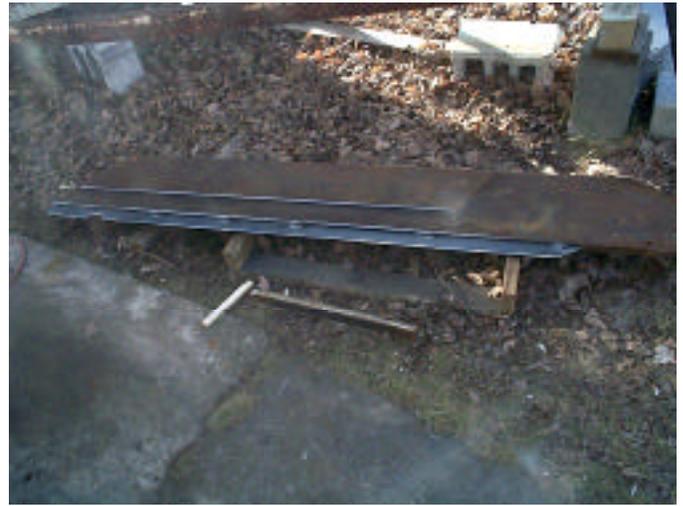
37. A look at the trailing edge. I also tried to bevel the edges of the plates a little.

After I dragged it out from under the boat, it was immediately obvious why it was stuck in the centerboard case. Water had found its way to the steel core decades ago. As the core started to rust, it expanded. Rust takes up a much larger volume than steel does. Rather than going through all the grief that I just went through, one of the previous owners just cut out the swollen spots with a Skilsaw and left the core exposed. It had been this way for years.

The only repair was to replace or relaminate the keel. Some of the old Ventures reportedly had solid cast iron keels, and I wish I could have found one. Repairing a cast iron keel involves sandblasting and painting, where composite keels must be relaminated with fiberglass.

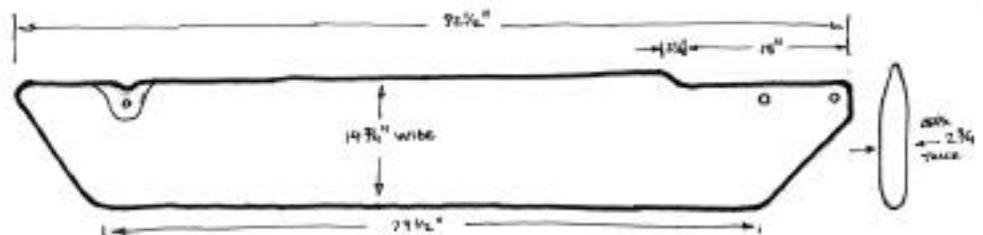
38. MacGregor Venture 222 keel dimensions (72 model with fiberglass composite keel, measured from my boat)

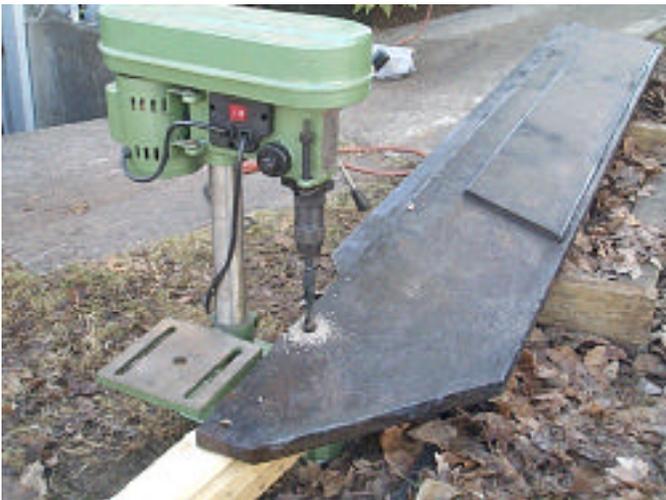
39. Drilling out the pivot hole for a larger size bolt

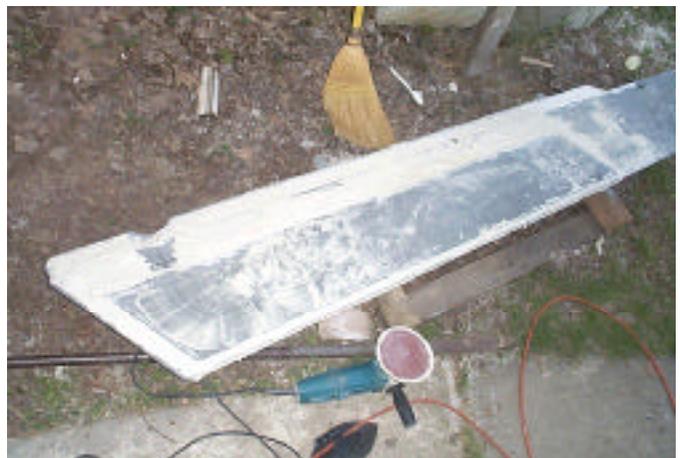
40. Here I've applied filler (resin and microballoons) , sanding is next

use the expensive epoxy. I mixed up some filler and troweled it in sanded it to shape, and laminated with three layers of glass. That’s when I noticed the tiniest gaps near the core and filler, where the polyester must have slightly shrunk. I had already used up a good amount of my materials that I’d bought for the keel, and was essentially committed, so I gave the cracks a coat of epoxy, then laminated another layer of glass with epoxy and turned it over. The other side was done in all epoxy. So far, it appears that the epoxy has sealed it up, but I wish I hadn’t used any polyester at all... and ended up throwing away half a gallon.

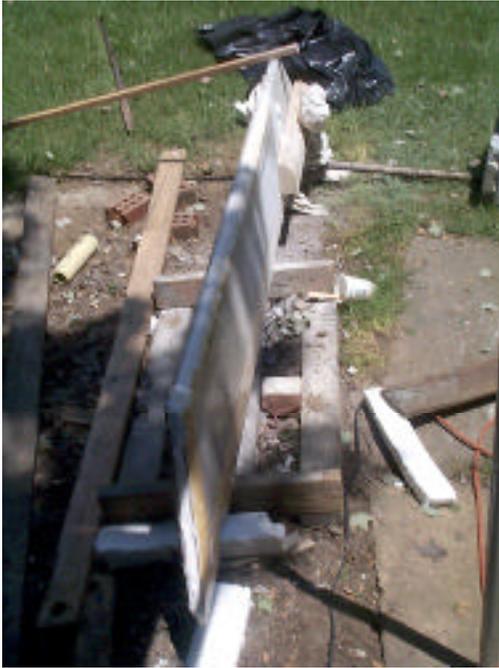
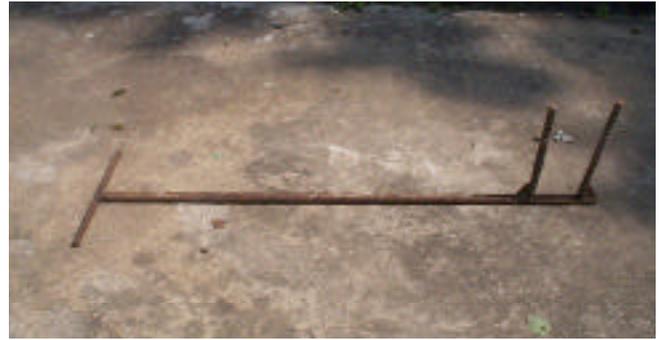
41. A look at my “keel fork,” above. It’s in use on the left, (42.)holding the keel upright so I can laminate the edge

Maneuvering the keel to work on it was extremely difficult, but I was able to do it with a “keel fork” that I welded together out of scrap re-bar (concrete reinforcing steel). I kept the keel on a wooden loading pallet so that I could get the fork under it to turn it, or work on its edge, etc. I had endless visions of this thing falling on my leg and breaking it, since it was about this time that I fell getting in and broke my wrist. It wasn't fun. If you need to do this with your boat, then I would seek professional help if at all possible. When you get back from the psychiatrist, then maybe you can find someone with an engine hoist to help you move this thing around while you work on it.
