### **Getting started**

### **Scraping the Exterior**

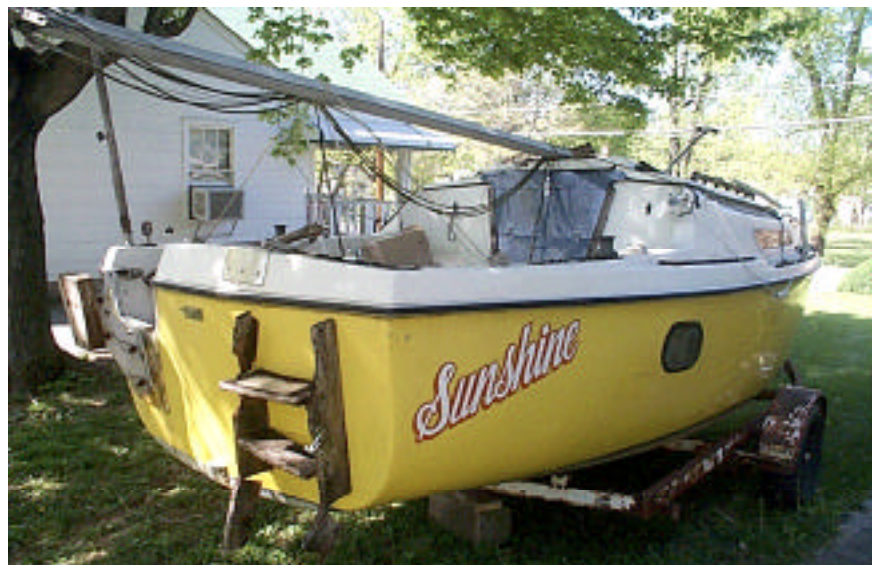
**13. Our new yard decoration, the day after it arrived at our house**

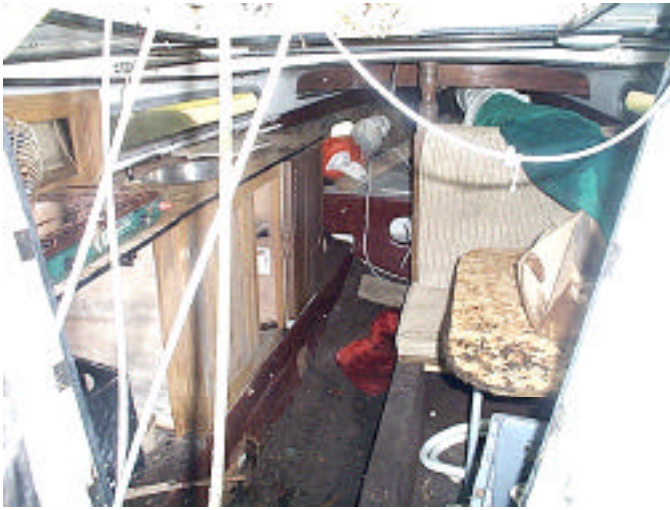
**14. The interior as the boat was found... it's the picture of neglect. I wish that I'd taken more "before" shots, but I think that I subconsciously wanted to deny that I'd actually paid money for this mess.**

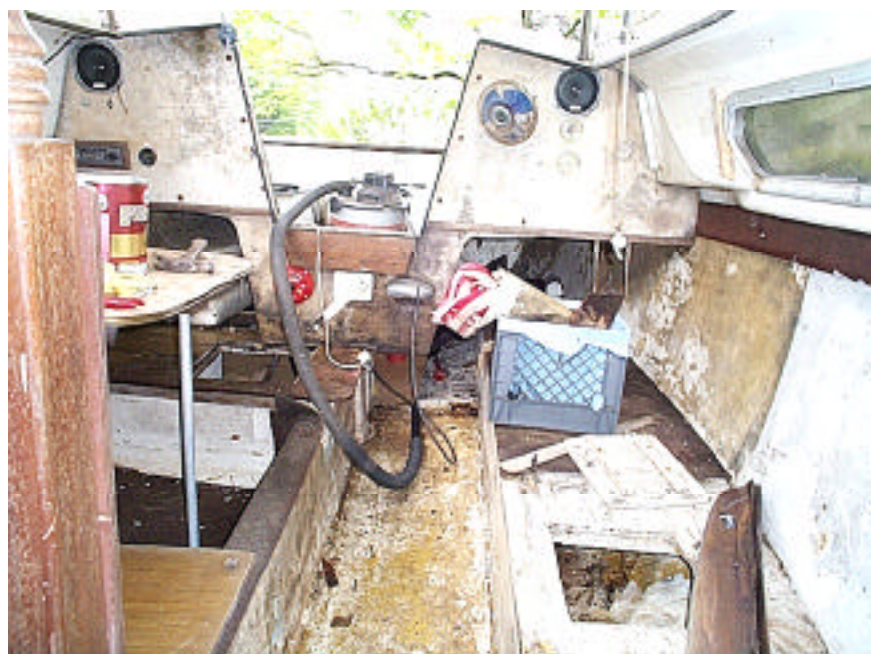
**15. An early image from the stripping and removal phase**

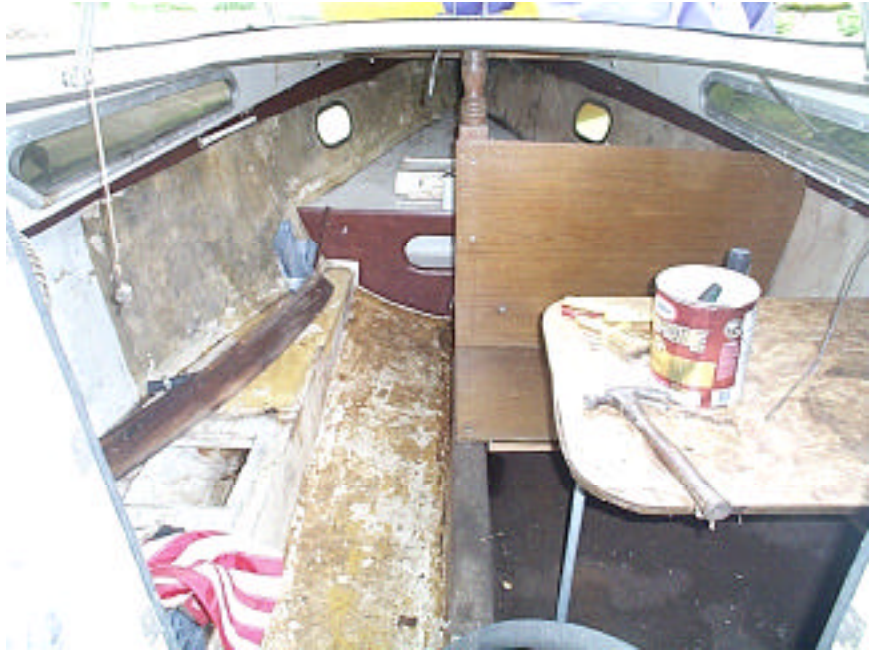
**16. More stripping of the interior. Most of the water soaked fabrics have been discarded, revealing a difficult surface beneath. It smells a little better, though.**

vinyl backed by foam rubber on the overhead. Once these surfaces mildew, and they nearly always do on a boat, it is difficult– if not impossible– to clean them. In my case, it wasn't only mildew, but rot that I had to worry about. Nearly all of this stuff was ripped out and thrown away, with no attempt to make patterns. I didn't want that much cloth on my boat anyway. The exception, of course, are the cabin cushion covers. They were the original cushions that were sold with the boat nearly thirty years ago. Considering their age, these weren't all that bad. While both the foam and the fabric need to be replaced, they can be placed low on the priority list. I did replace them, though, since some were missing. This is a good job to tackle in the winter months, when it's freezing cold in the boat.

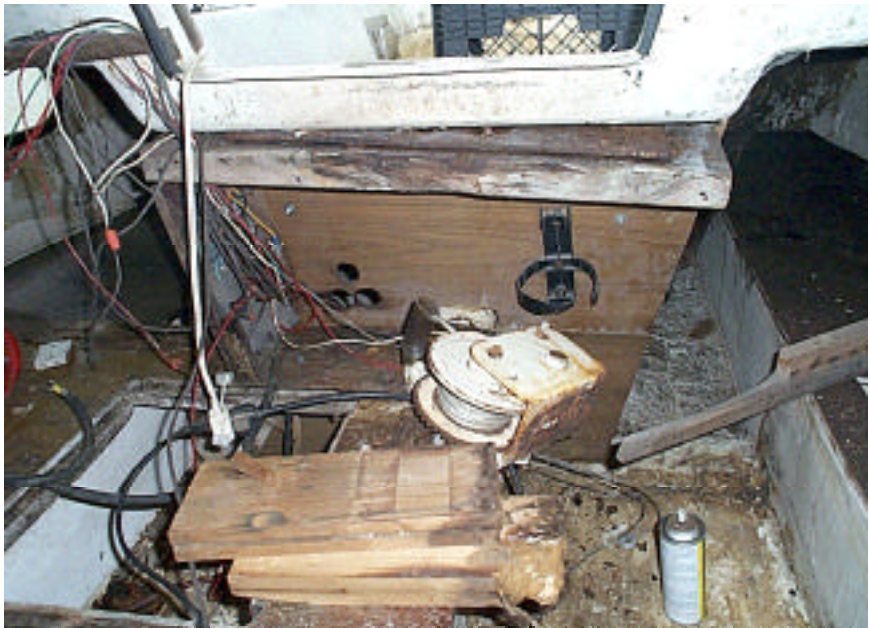
**17. Removing a covering panel revealed this view of the winch. Here are a host of problems, including rot, faulty repairs to the winch support, and a concealed "electrical system" that was humorous at best, dangerous at worst. Note the location of the fire extinguisher bracket... totally inaccessible in an emergency.**

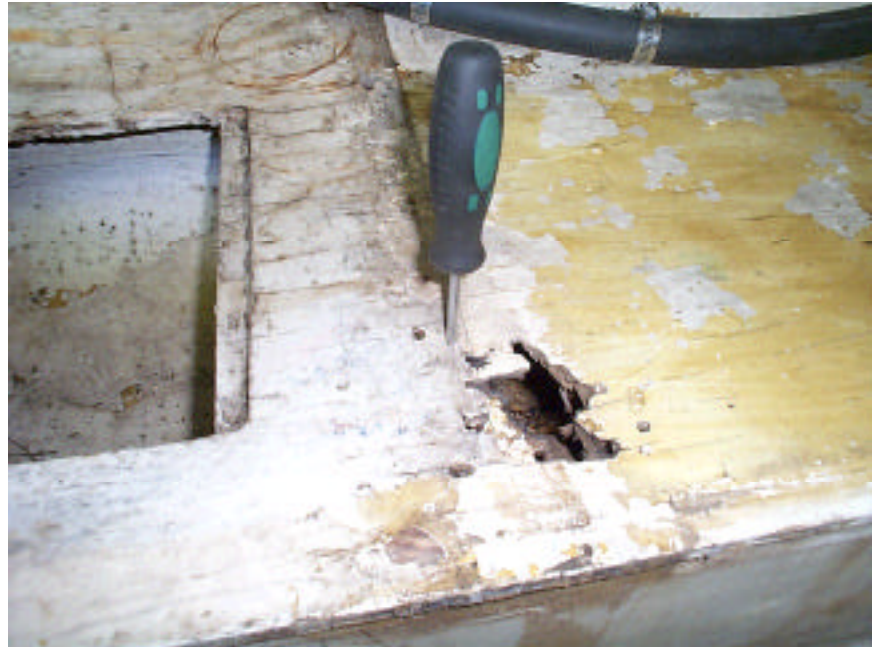
**18. Rot in a plywood berth top. This was a result of a poorly located front-opening icebox. It also shows how an icepick or small screwdriver can easily locate rotten sections.**

The 72 model Venture didn't have a liner. Older boats such as mine had an interior that was pieced together from individual plywood panels and bonded to the hull. This method of construction can result in a stronger structure, but more plywood means more chances for rot. Fortunately, it appeared that MacGregor had used either some form of marine grade plywood or at least a good grade of exterior plywood, since I found remarkably little rot in the basic structure of the boat. The front loading icebox that the previous owner installed had leaked over the years, and the constant cycle of dampness and drying (and dripping condensation) had rotted out the panel directly beneath it, with the worst areas near the bolt holes. (This area was

Front-loading iceboxes are not a good idea. Cold air sinks, and every time the door opens you lose precious cold air. Top loaders, though less convenient to organize, keep ice better. Insulation is paramount, and on stock boats, always inadequate. Four inches on all sides isn't too much. A conventional cooler can be modified by adding extra foam, but it needs to be carefully sealed to prevent becoming a mildew farm. A workable option might be by nesting a soft cooler inside a larger rigid one, if you can find a pair that fit closely together.

repaired later by enlarging a locker lid... a discussion of this process is under “Structural woodworking.”)

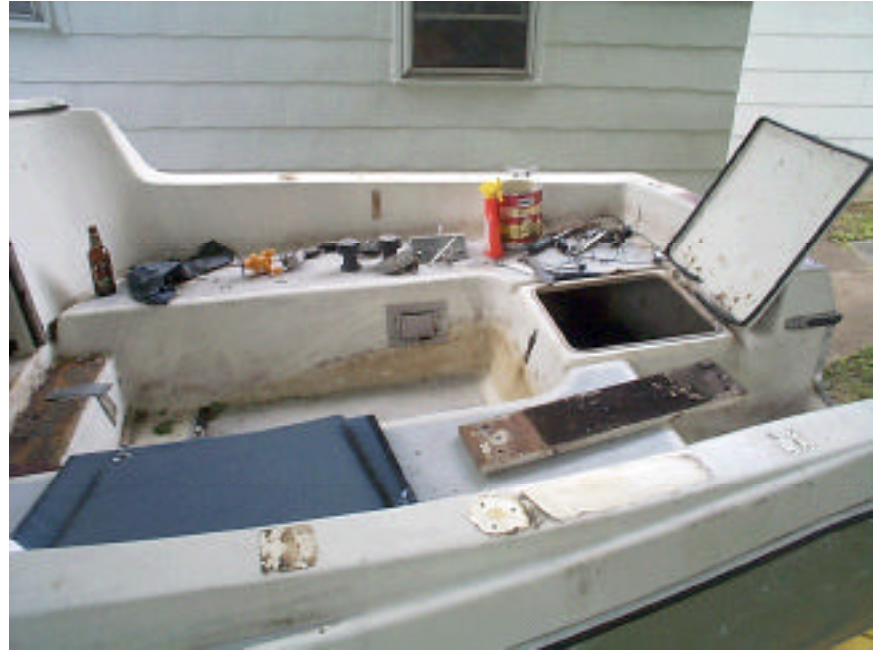
**19. Stripping the exterior. This image also illustrates the “mud line” that resulted when the cockpit was left full of rainwater. It also illustrates evidence of minor alcohol consumption, a necessary by-product of the work’s magnitude.**

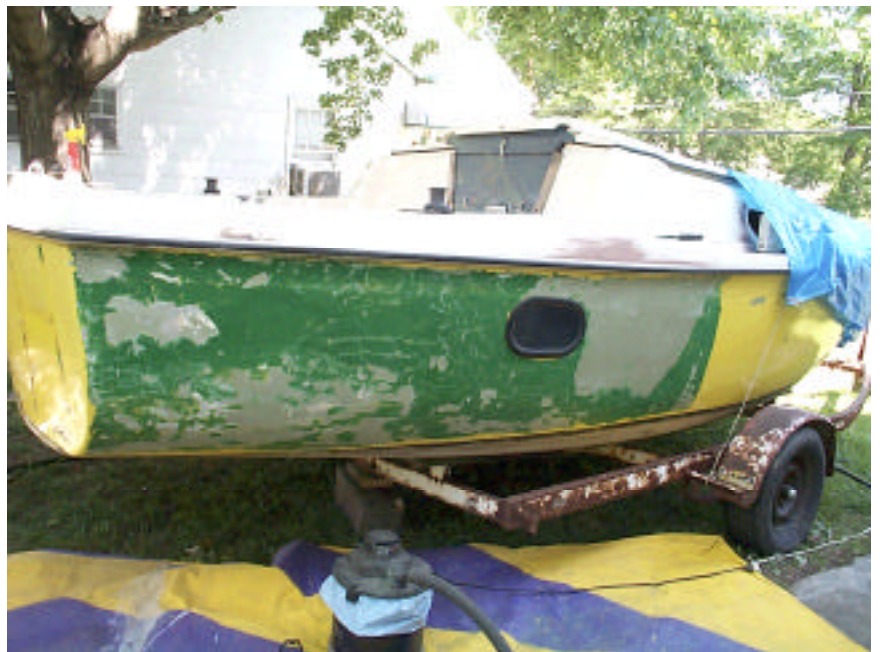
**20. Starting to scrape the hull. The yellow automotive paint came up easily in some places, but stuck tight in others. The green layer was probably an earlier paint job, and the original factory gel-coat was probably a thin layer of light blue that was underneath the green.**

The goal was to get the boat down to a nearly bare hull and deck. Since the boat obviously leaked badly, all the fittings needed to be rebedded. I planned to strip off all the old paint, apply new paint, then reattach all the parts with new bedding compound. This always looks better than trying to paint around fittings and wooden parts, and most of the fittings needed reconditioning anyway.
