Painting the exterior

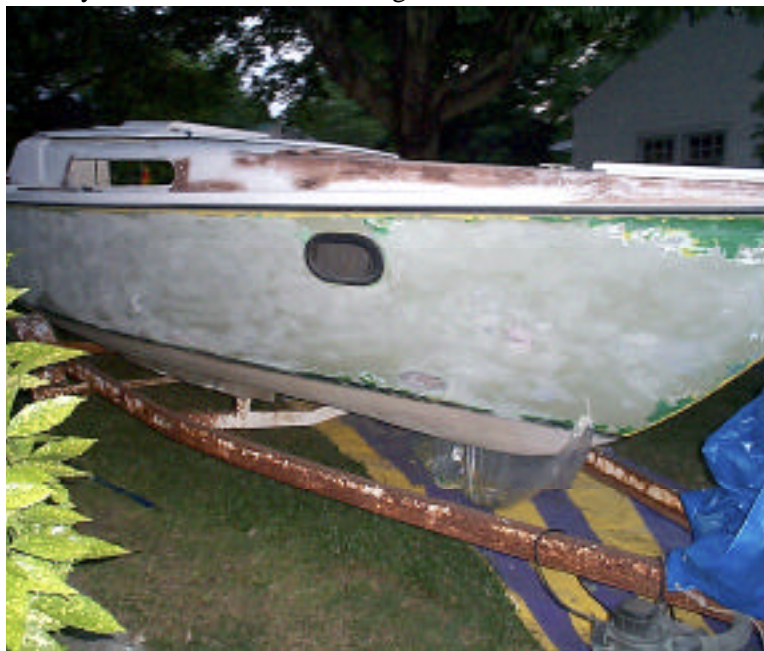
69. The exterior paint job at the start of the project. A little more scraping and sanding remains to be done around the bow.

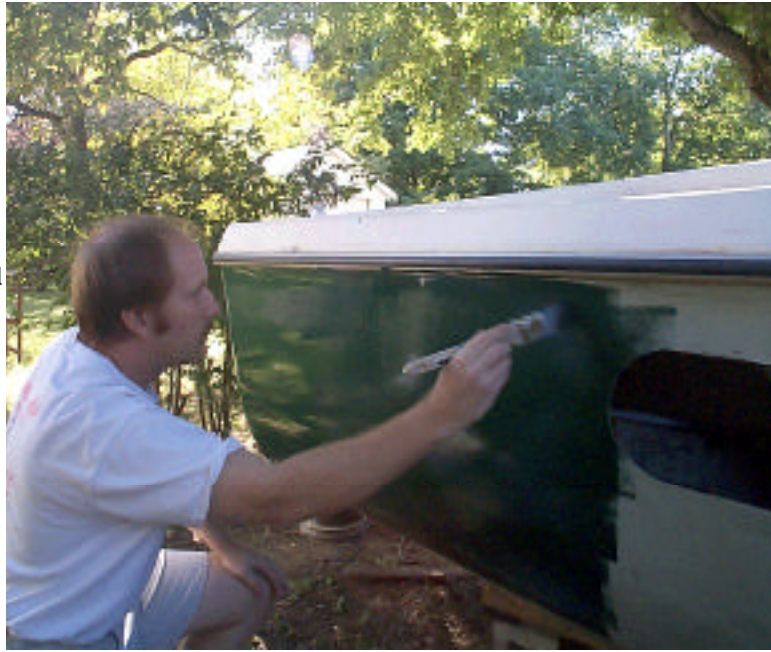
70. Drybrushing the hull. The paint has been rolled on, leaving a very bubbly and rough surface. Lightly stroking with the brush pops the bubbles and smooths the surface greatly.

It works best if you have a helper or two, but it can be done by one person. Here’s how it works. Using the paint manufacturer’s special brushing thinner, a batch of paint is thinned to a consistency of heavy cream. This is rolled onto the hull with a foam roller cover. (NOT a household roller cover that you can get from Lowes... they’ll fall apart and ruin the job) At this point the paint will slightly resemble the surface of an orange peel. While the paint is still wet, the finish is tipped off by gently stroking it with a good brush. This smooths the finish considerably.

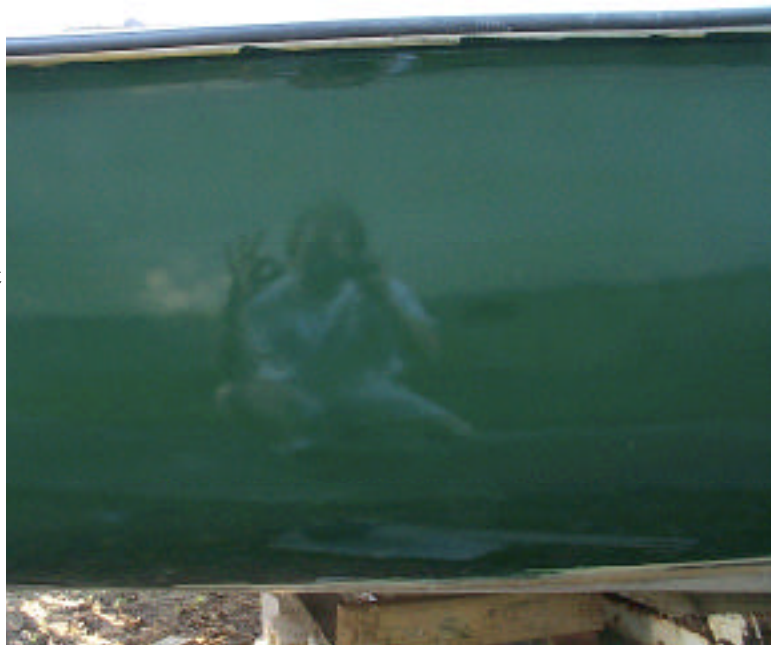
71. The resulting gloss. I was very pleased with the performance of the Petit one-part poly, though I’ve heard that two-parts give even greater gloss.

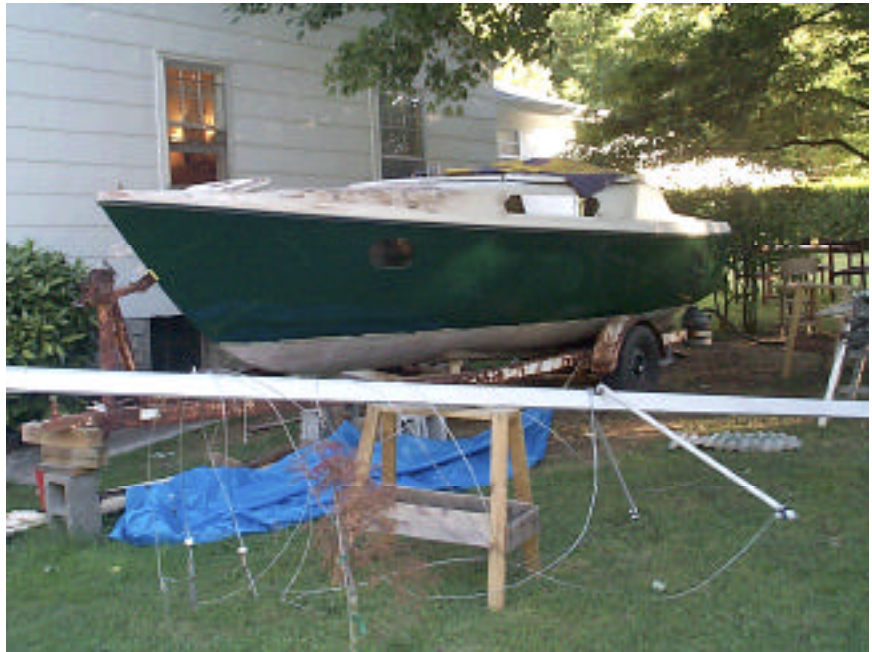
72. The hull after the first coat of green polyurethane.
